IMPACT STUDY OF REGULATOR CUM BRIDGES

PROJECT REPORT

Agricultural Engineering

2013

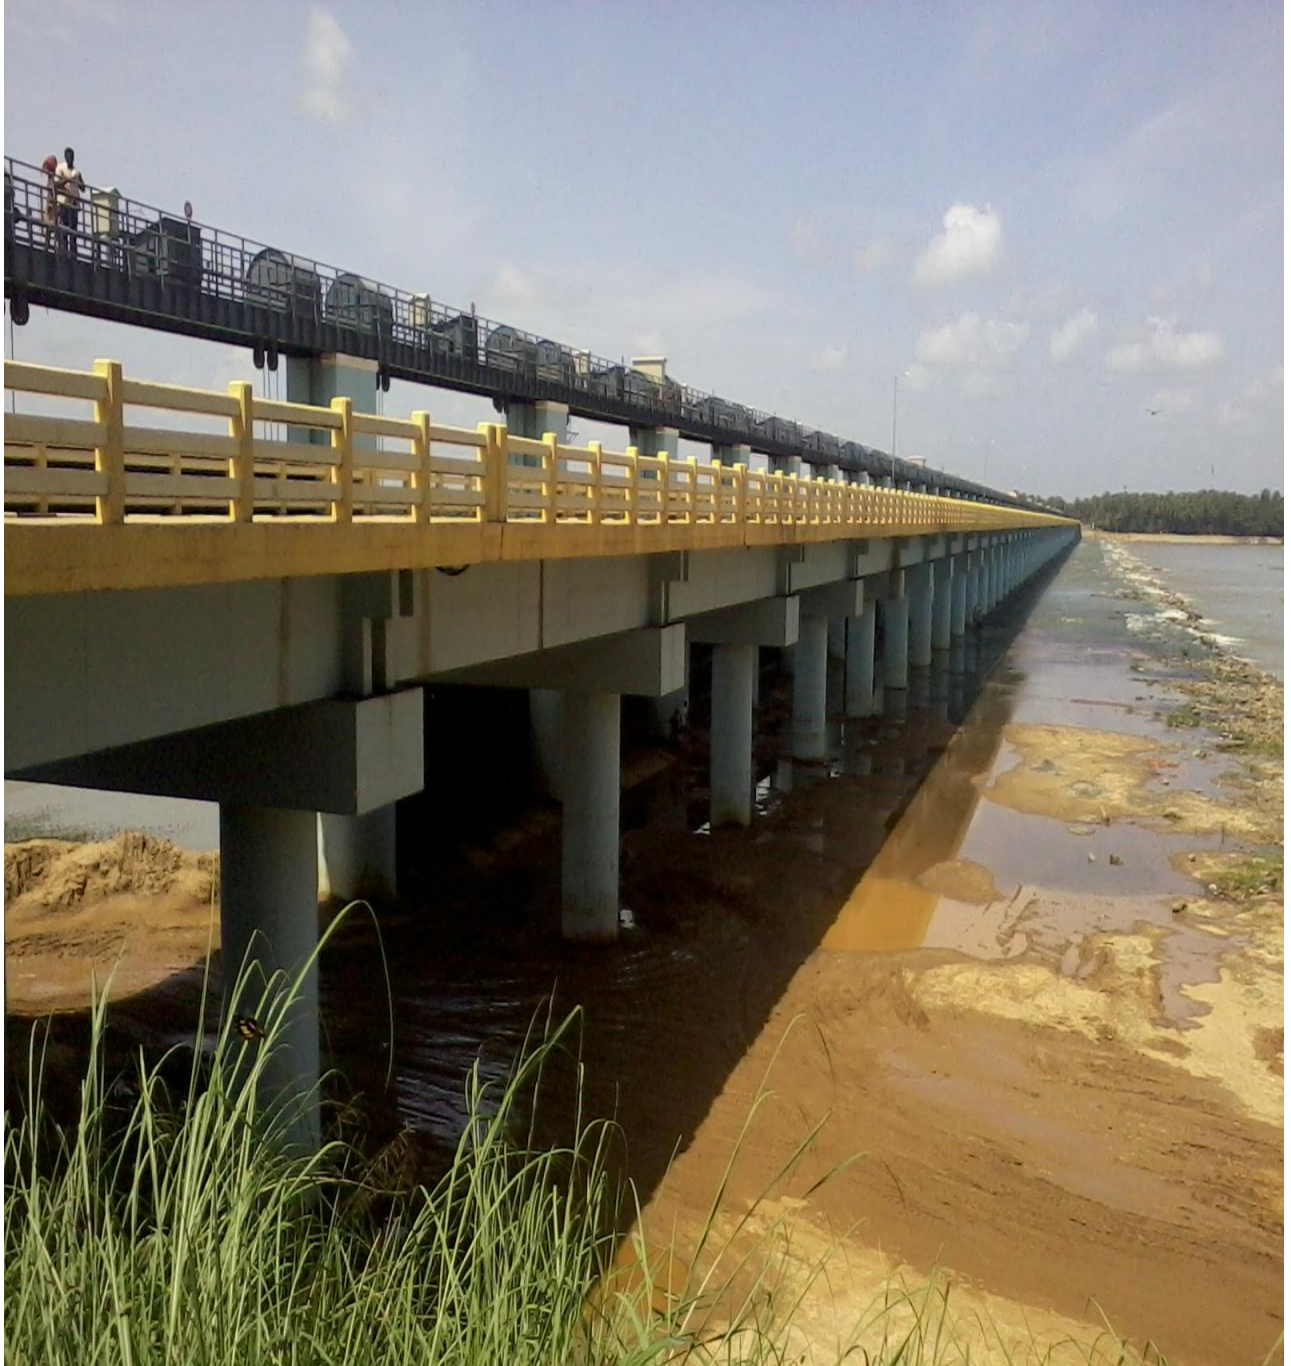
Plate 1. Chamravattom Regulator cum Bridge

(i) Width of the river at RCB site	:	1000m
(ii) Length of the RCB	:	978m
(iii) Number of shutters	:	70 Nos.
(iv) Size of shutters	:	12 x 4 m
(v) R.L of the river bed	:	+1.5 m
(vi) Proposed FRL of reservoir	:	+6.00 m
(vii) Storage capacity	:	24.49 Mm ³
(viii) Water spread area	:	868 ha
(ix) Maximum flood discharge	:	8496 m ³ /sec
(x) Mean annual rainfall	:	2721 mm
(xi) Width of roadway	:	7.5 m
(xii) R.L of roadway	:	+9.35 m
(xiii) B/C Ratio	:	@5% =5.9, @10% =2.90

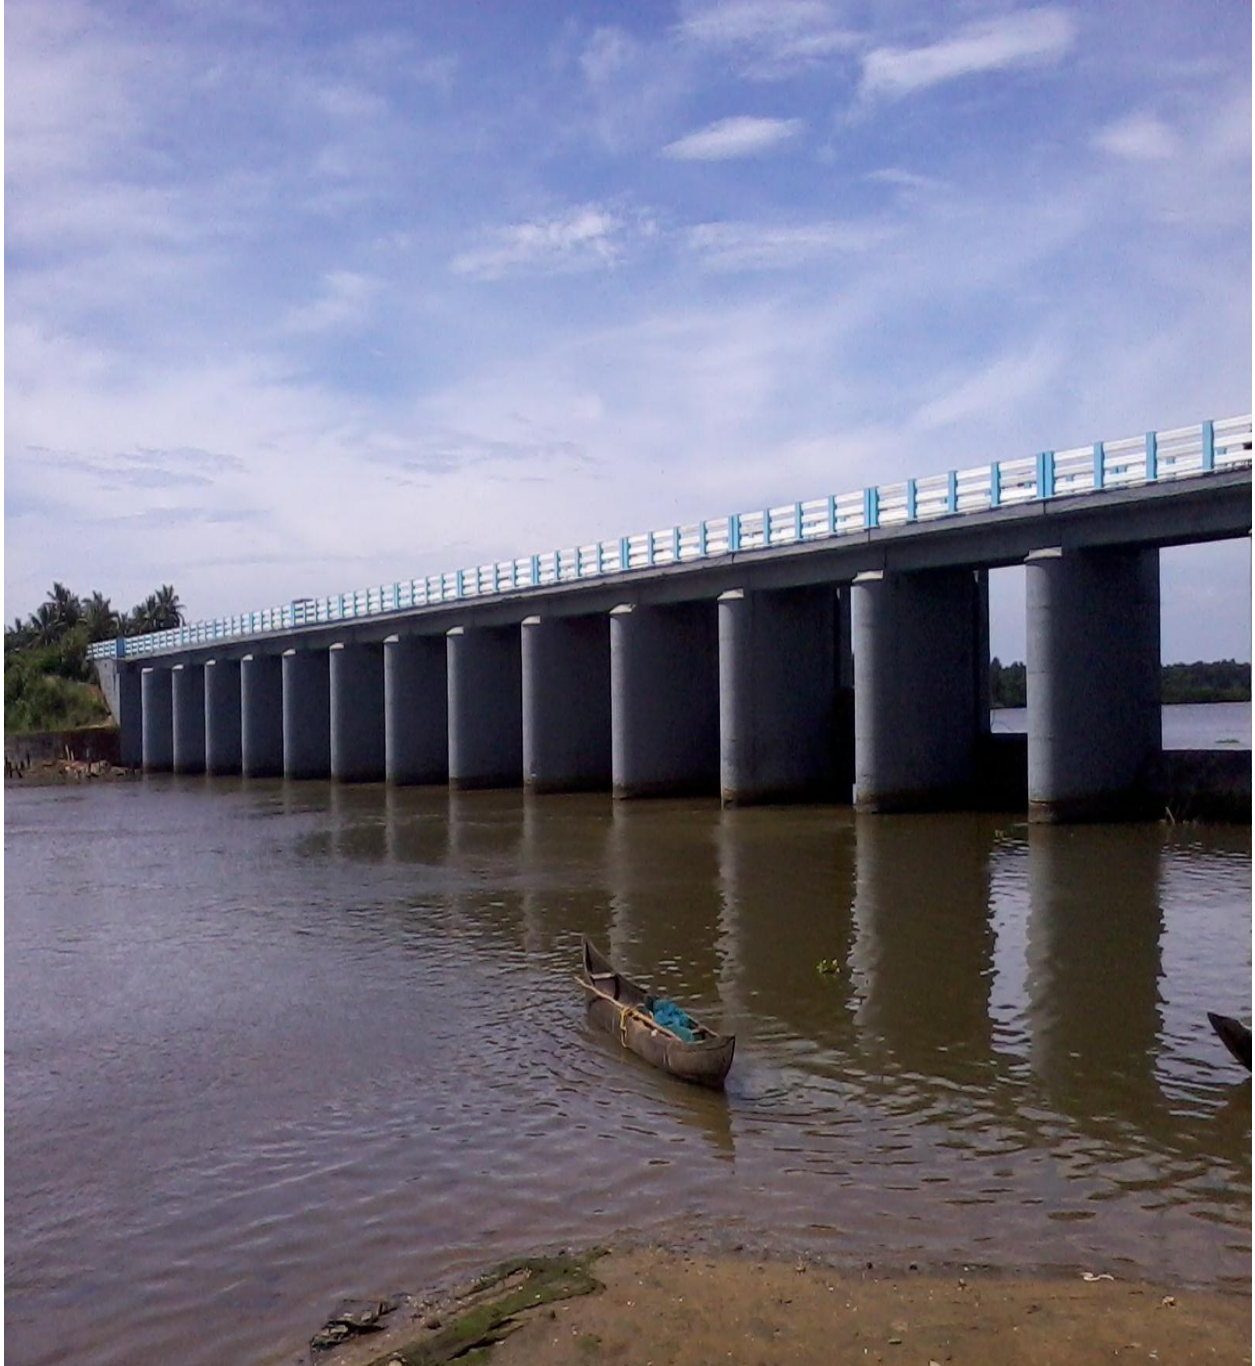
Plate 2. Kootayi Regulator cum Bridge

Total span	:	16 m
+Clear span	:	6.1 m
Clear road width	:	4.27
Top level of road	:	+ 7.010 m
M FL	:	+ 1.89
Top level of shutter	:	+1.525 m
Ground level	:	+ 1.2 m (Mangalam) + 1.3 m (Koottati)
Retention level	:	+ 1.3 m
Low tide level	:	+ 0.49 m
Still level	:	-1.20 m
Width of apron	:	21.35 m
Thickness of pier	:	1.22 m
Size of shutter	:	6.1 m * 2.89 m
Ayacut benefited	:	2450 acre
Discharge of river	:	270 m ³ /s

Construction of a lock-cum-regulator-cum-bridge at Koottai across Tirur Ponnappuzha in Malappuram District were awarded in 1979 and 1981 respectively, the department was forced to terminate the contract in December 1981 and June 1984 after completing 14 out of the 25 spans, The original proposal was for construction of 24 spans and a lock chamber. Out of the above 24 spans, 14 spans were completed. The work was held up due to various technical reasons. The fixing of shutters for the completed spans could not be arranged due to various factors. The above work was proposed twenty years back and at that time no other projects were executed and water was not stored in the upstream portions of Bharathapuzha. Later a number of projects such as Chulliyar, Meenkara, Pothundy, Kanjirappuzha, Mangalam etc were executed in addition to the major project, Malappuzha. Hence the discharge of water in the river basin has been considerably reduced. Moreover the Koottai regulator was designed considering the flood of 1924, which was the peak flood. Since 1924 no such flood had occurred and even if such a flood could occur the above mentioned projects could absorb a major portion of the flood. Hence after considering all the above facts the Chief Engineer, Irrigation and Administration and Chief Engineer IDRIB jointly decided to reduce 4 spans from the original proposal of 24 spans.

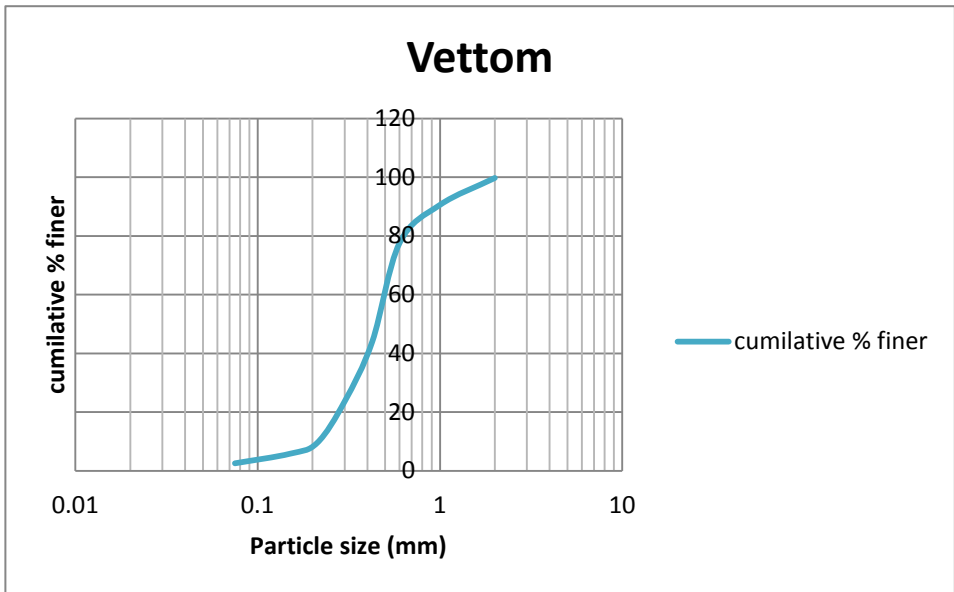
The result of the mechanical analysis are plotted to get particle size distribution curve with the percentage finer as the ordinate and particle diameter as the abscissa, the diameter being plotted on a logarithmic scale. The particle size distribution curve gives an idea about the type and gradation of soil. A curve situated higher up or to the left represents the coarse grade soil. A soil sample may be either well graded or poorly graded. A soil is said to be well graded when it has good representation of particles of all sizes. On the other hand a soil is said to be poorly graded if it has most of the particle of about the same size. The particle size distribution curves are shown in Fig. 4.1 to 4.6.

Fig. 4.1 Particle size distribution of soil from Vettom

The C_u and C_c values of the soil samples are shown in table 4.6.

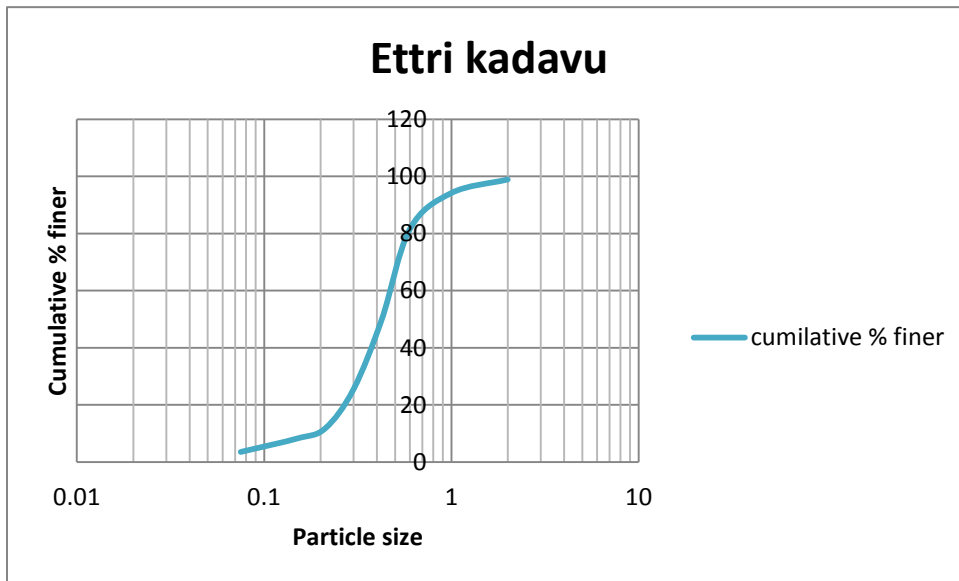
Fig . 4.4 Particle size distribution of soil from Ettrikadavu
