**IMPACT STUDY OF CHAMRAVATTOM AND
KOOTAYI REGULATOR CUM BRIDGES**

Department of Land and Water Resources & Conservation Engineering

KELAPPAJI COLLEGE OF AGRICULTURAL ENGINEERING AND TECHNOLOGY

PROJECT REPORT

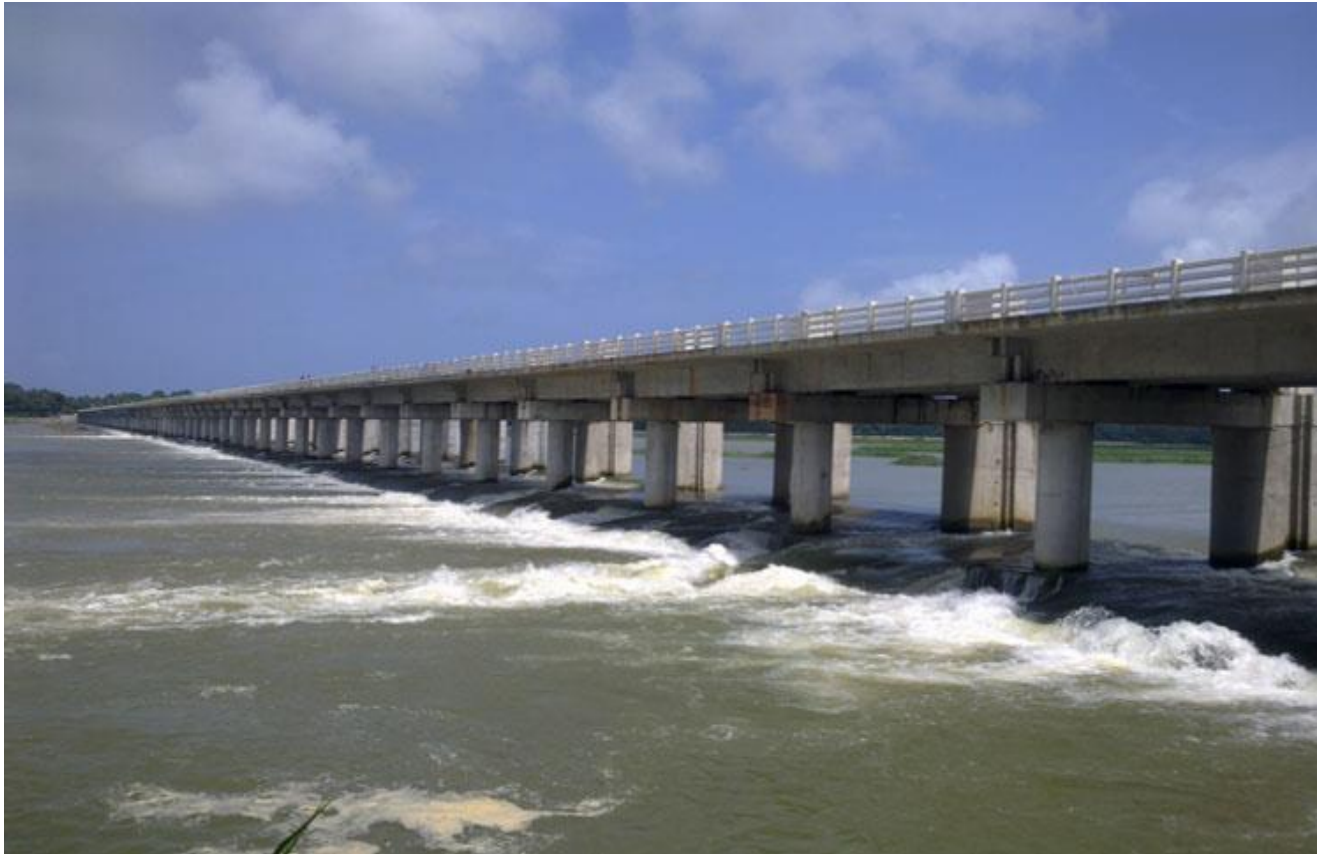
Plate 1. Chamravattom Regulator cum Bridge

The project is proposed to stabilize the ayacut area maintained by L.I.Scheme in the area that have been commissioned by the State Irrigation Department so far. Project is also aimed for the formation of additional sluices, extending canals, replacement of motors and pumps, improvements to the existing canals, shifting of pump house etc. The drinking water supply schemes face acute shortage of water during the summer, solution to which is also answered better from this scheme. Another important aim of this project is the effective control of the intrusion of saline water into the upstream side of the regulator. Besides, the river when bridged will be an important link connecting the coastal towns of Ponnani and

Tirur and thereby reducing the distance 20km by road. This also reduces the distances between Ernakulam and Calicut and thereby contributes very much to the development of the coastal towns.

Geology and foundation

Hard rock has been met with at depth of 18.75 m to 42.20 m and foundation is pile

A site 6 km upstream of river mouth was found most suitable. Hence the average the average bed level of the river is + 1.5m. and bank level is average + 4.5 m.

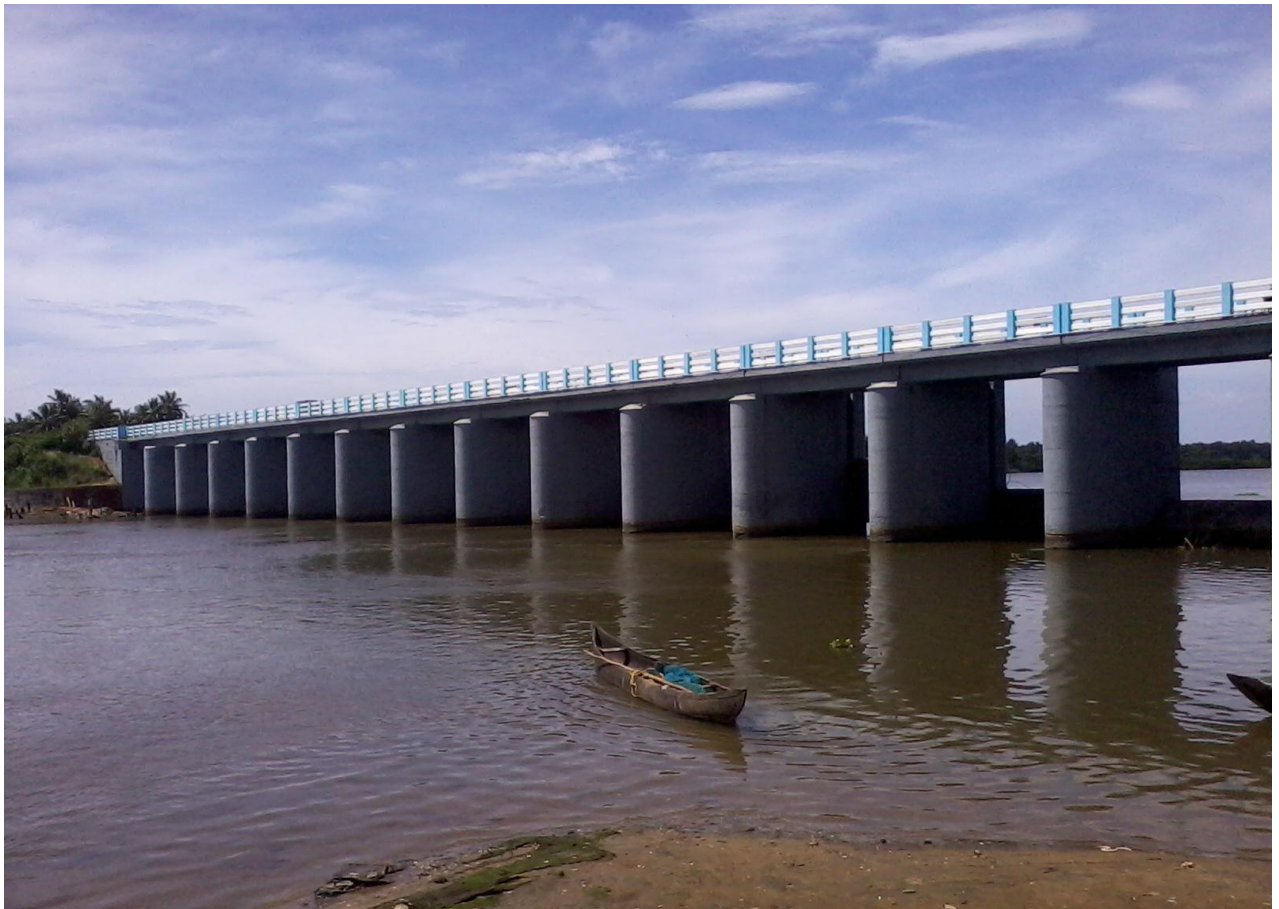
Plate 2.Kootayi Regulator cum Bridge

Construction of a lock-cum-regulator-cum-bridge at Kootayi across Tirur Ponnani in Malappuram District were awarded in 1979 and 1981 respectively, the department was forced to terminate the contract in December 1981 and June 1984 after completing 14 out of the 25 spans, The original proposal was for construction of 24 spans and a lock chamber. Out of the above 24 spans, 14 spans were completed. The work was held up due to various technical reasons .The fixing of shutters for the completed spans could not be arranged due to various factors. The above work was proposed twenty years back and at that time no other projects were executed and water was not stored in the upstream portions of Bharathapuzha. Later a number of projects such as Chulliyar, Meenkara, Pothundy, Kanjirappuzha, Mangalam etc were executed in addition to the major project, Malampuzha.

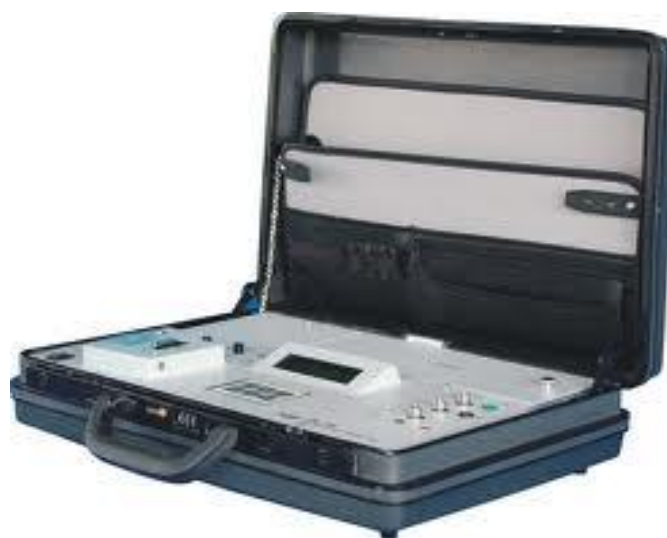
Plate 3 . Water Analyser

Press ESC display returns to the Main Title, or Press ENTER to display results.

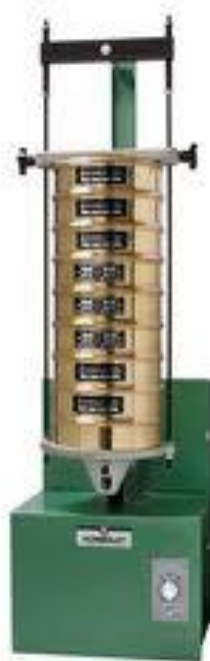
Plate 4 . Sieve apparatus

Where, D60 is the grain diameter at 60% passing, D30 is the grain diameter at 30% passing, and D10 is the grain diameter at 10% passing.

Soil gradation is a classification of a coarse-grained soil that ranks the soil based on the different particle sizes contained in the soil. Soil gradation is an important aspect of soil mechanics and geotechnical engineering because it is an indicator of other engineering properties such as compressibility, shear strength, and hydraulic conductivity. In a design, the gradation of the in situ or on site soil often controls the design and ground water drainage of the site. A poorly graded soil will have better drainage than a well graded soil. Soil is graded as either well graded or poorly graded. Poorly graded soils are further divided into uniformly-graded or gap-graded soils. Soil gradation is a classification of the particle size distribution of a soil. Coarse-grained soils, mainly gravels or sands, are graded as either well graded or poorly graded. Poorly graded soils are further divided into uniformly-graded or gap-graded soils.

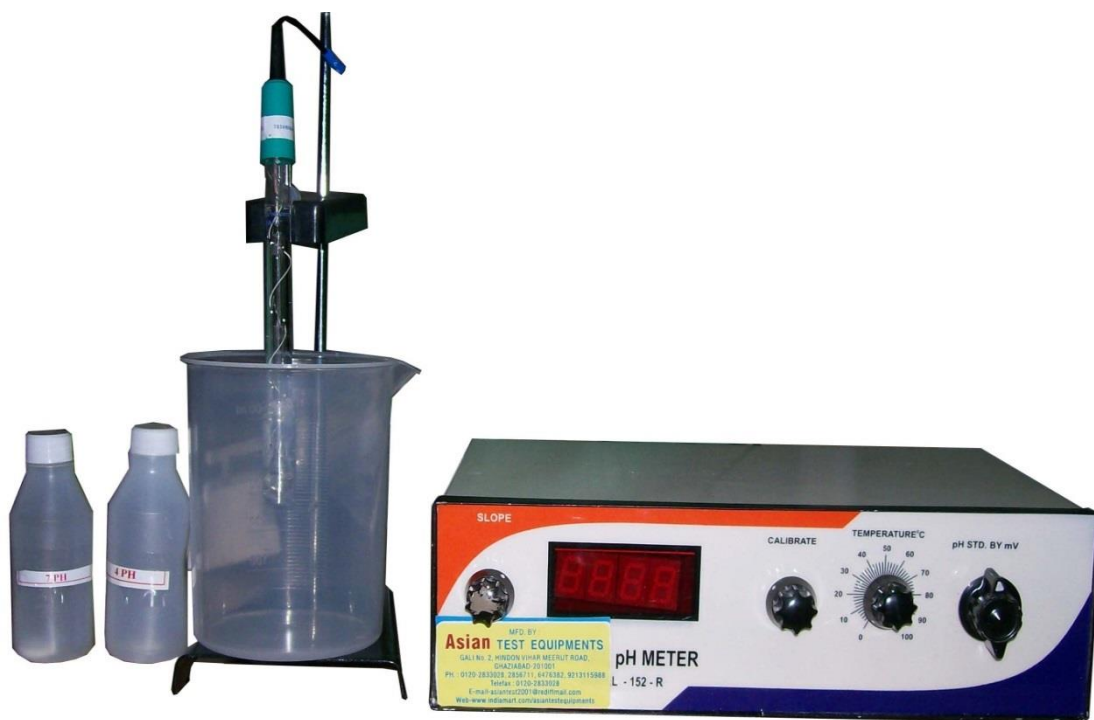
Plate 5. pH Meter

Soil samples collected from five selected sites of the upstream of Chamravattom Regulator Cum Bridge and these samples were kept in shade for drying. Dried samples passed through 2 mm IS sieve, 10 gm of soil sample is selected from this for the test sample preparation. 10 gm soil sample was mixed with 25 ml of distilled water in a beaker, stirred well and kept it for 30 minutes. 7 pH and 4 pH buffer solution were used for the calibration of pH meter. After calibration the pH meter readings were taken by dipping the electrode in the sample and digital scale read is noted.

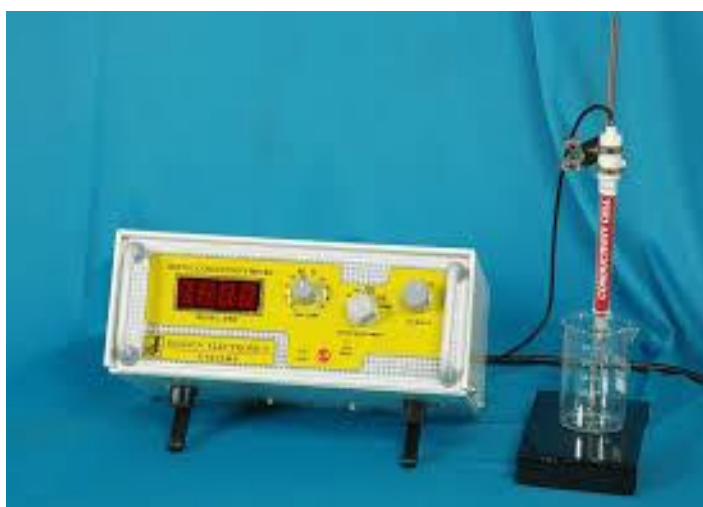
Plate 6 . Conductivity meter

The sample preparation was same as that of sample prepared for pH determination. The conductivity meter was first calibrated using standard NaCl solution. The units were calibrated by adjusting the value on the meter to read the value of constants. This was done by using either increase or decrease button on the meter or using a small tool. The conductivity meter readings were taken by dipping the conductivity probe in to the sample

and the digital scale read is noted. Its important to ensure that any air bubbles are removed from the probe. To do this the probe was gently tapped on the sides of the graduates. The readings on the meter were then allowed to stabilize and the value is recorded.

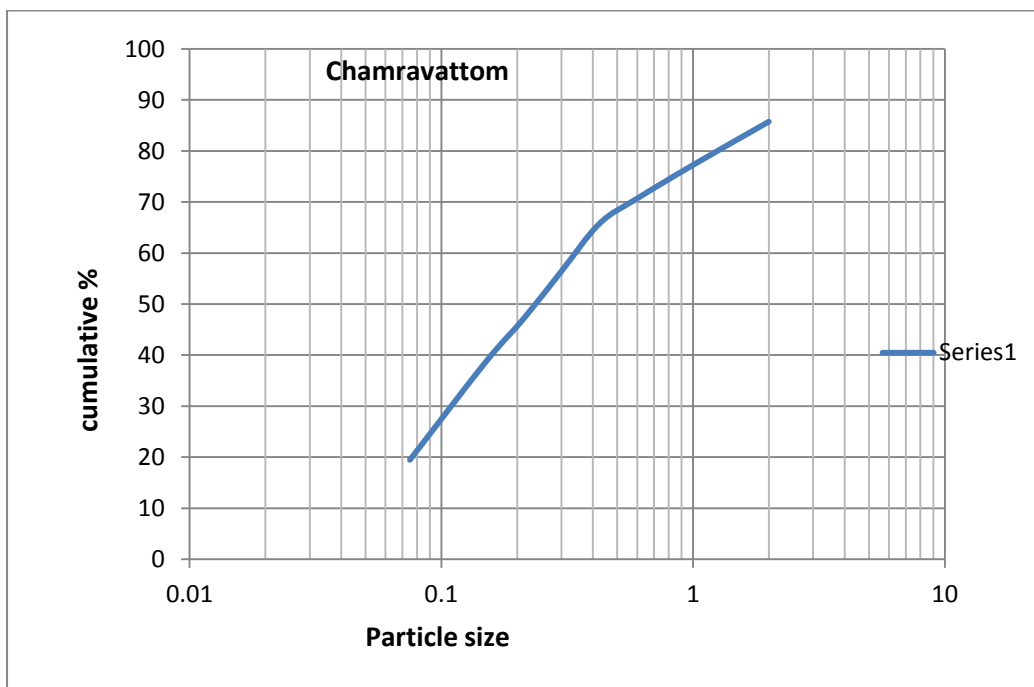
Fig . 4.1 Particle size distribution of soil from Chamravattom

The result of the mechanical analysis are plotted to get particle size distribution curve with the percentage finer as the ordinate and particle diameter as the abscissa, the diameter being plotted on a logarithmic scale. The particle size distribution curve gives an idea about the type and gradation of soil. A soil sample may be either well graded or poorly graded. A soil is said to be well graded when it has good representation of particles of all sizes. On the other hand a soil is said to be poorly graded if it has most of the particle of about the same size. The particle size distribution curves are shown in Fig. 4.1 to 4.5. All the soil samples have $C_u \leq 2$ and $1 < C_c < 3$, which indicates that samples are well, graded gravels. Soil gradation is very important to geotechnical engineering. It is an indicator of other engineering properties such as compressibility, shear strength, and hydraulic conductivity. A poorly graded soil has better drainage than a well graded soil because there are more void spaces in a poorly graded soil. A well graded soil is able to be compacted more than a poorly graded soil. Particle size distribution by sieve analysis is shown in Appendix I.

The Cu and Cc values of the soil samples are shown in table 4.8.
