**ASSESSMENT OF THE IMPACT OF SAND MINING ON THE  
MORPHOLOGY OF THE SEVERELY AFFECTED REACH OF  
BHARATHAPUZHA RIVER BETWEEN PATTAMBI AND KUTTIPPURAM  
USING REMOTE SENSING AND GIS**

**DEPARTMENT OF IRRIGATION AND DRAINAGE ENGINEERING  
KELAPPAJI COLLEGE OF AGRICULTURAL ENGINEERING AND  
TECHNOLOGY**

**THESIS**

**Master of Technology**

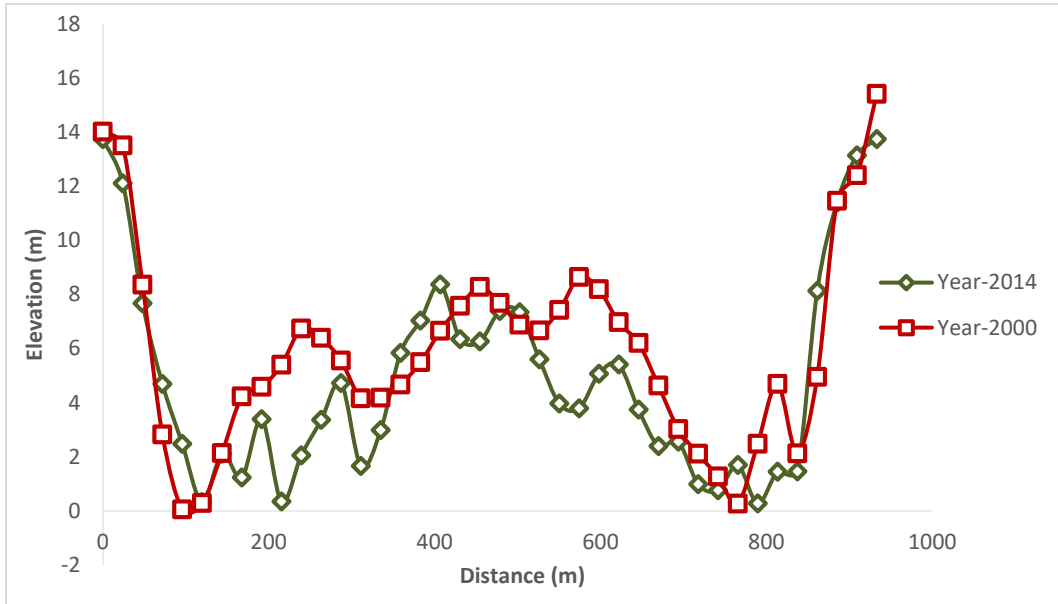
**Fig. 4. 1 Cross profile of section A during 2000 and 2014**

Section A located at  $10^{\circ} 51' 27.2''$  N,  $76^{\circ} 00' 41.7''$  E is known as Vellanchery Kadavu. This section also depicted a highly undulating cross section which describes the area with extreme rate of sand mining. The rate of downcutting was high than the rate of channel widening. The average change in depth was 1.03 m. The section observed an area change of  $968.98 \text{ m}^2$  due to erosion. The main cause of such a large change in area was explained by the severity of sand mining in the section. This section was the wider section among all other sections. Field visit had depicted the drastic situation of the area with many depressions here and there in the channel section leaving the section unlevelled. The highest area change was also resulted in the same section. This section was considered as one of the mostly affected area due to illegal sand mining. Fig. 4.1 represents the change in depth along the section A.

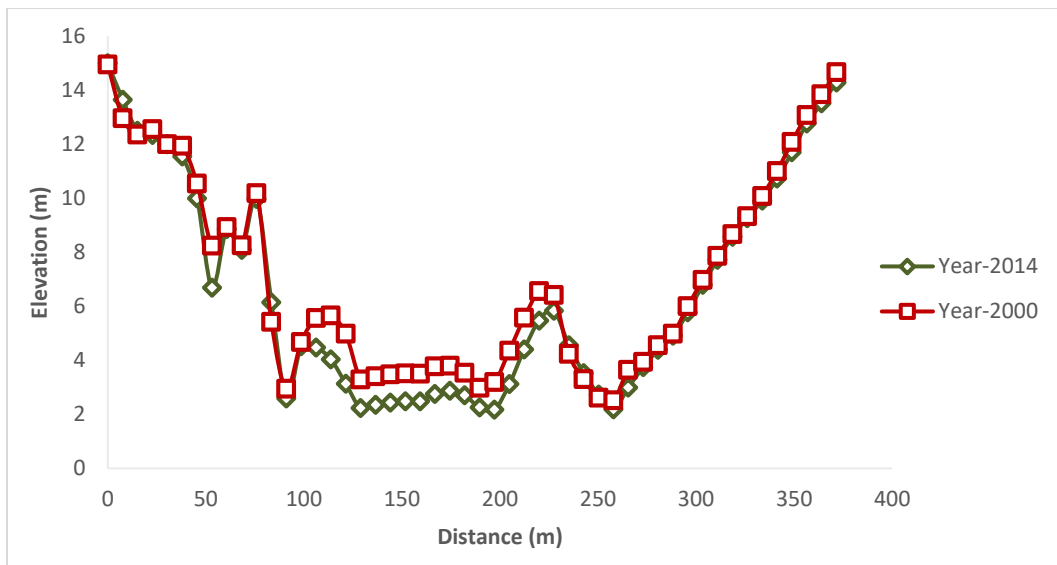
**Fig. 4. 6 Cross profile of section F during 2000 and 2014**

Section F is known as Kumbidi Ner Kadavu and is located at  $10^{\circ} 50' 18.2''$  N,  $76^{\circ} 02' 22.5''$  E. Cross profile of the section indicated that the area was highly undulating which explained that the river bed had been disturbed largely. The average change in depth was 0.47 m. The area had suffered erosion of about 178.94  $m^2$ . The morphological changes in this section was caused mainly due to scouring which had change the bed elevation greatly. A slight amount of channel widening was also seen in the section, but the rate was less compared to the downcutting. The information provided by the nearby people explained the reason of downcutting to be the illegal sand mining. These Kadavus were and are still sites of sand extraction. Among the all other anthropogenic activities the sand extraction was the main reason of destruction of the river channel. Fig. 4.6 represents the change in depth along the section F, it makes clear the picture of the section.

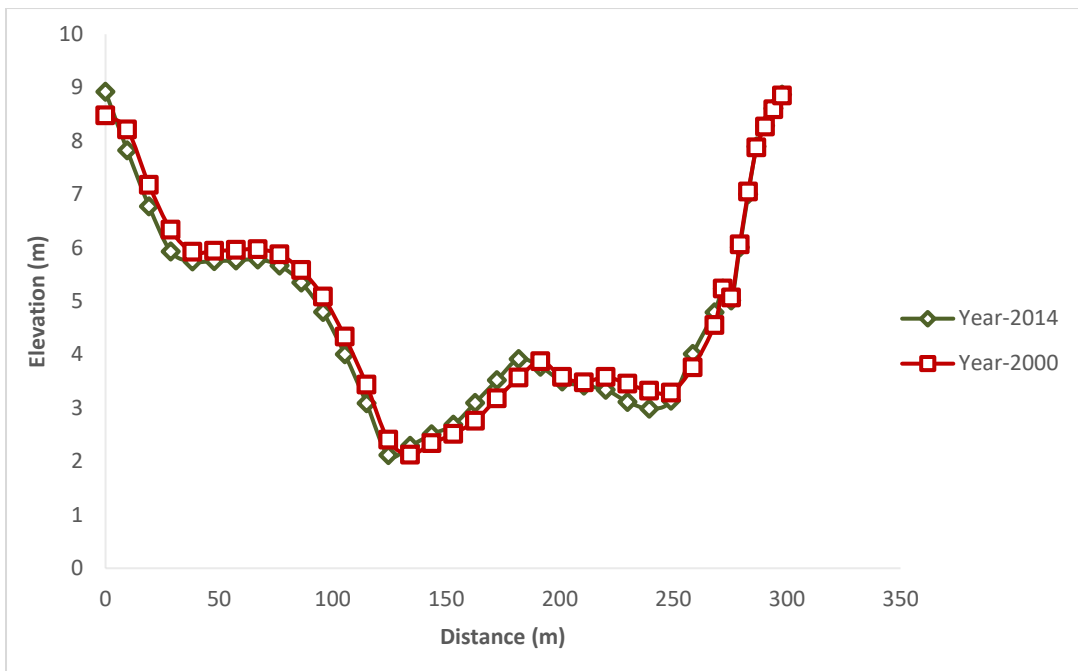
**Fig. 4. 7 Cross profile of section G during 2000 and 2014**

Section G located at  $10^{\circ} 50' 44.4''$  N,  $76^{\circ} 02' 16.0''$  E represents the School Kadavu in the field. Cross profile of the section indicated that section had undergone channel widening and scouring. The change in depth was caused due to channel scouring due to sand extraction. Channel widening was the result due to lateral erosion. The average change in depth of the section was found to be 0.07 m. Channel eroded about  $27.015 \text{ m}^2$ . Details obtained from local people justified the reason of change was due to illegal sand mining. Fig. 4.7 represents the change in depth along the section G.

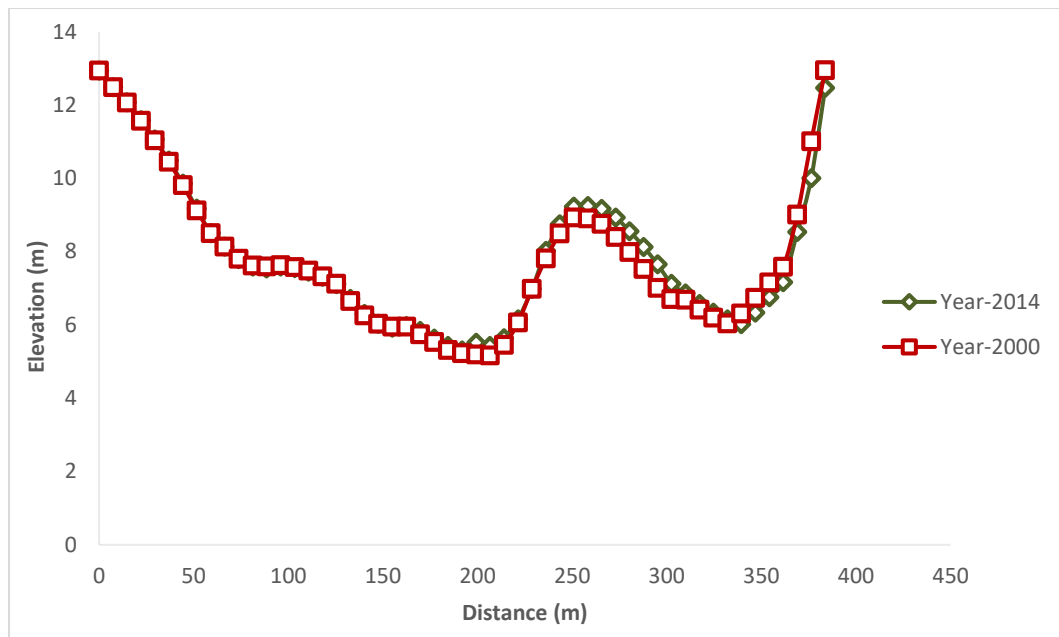
**Fig. 4. 12 Cross profile of section L during 2000 and 2014**

Section L is located at  $76^{\circ}10'20.359''\text{E}$ ,  $10^{\circ}47'42.253''\text{N}$ . The cross profile of the section denoted that only a less change had occurred in the whole section. No significant channel widening had been noted in the section but a small amount of deposition was visible in some parts of the area. The average change in depth of the section was 0.05 m. The section had a deposition of  $22.05\text{ m}^2$  in area. The change was seen only in a small area of the section. The result denoted that the section was

not affected by sand mining in a high rate. Fig. 4.12 represents the change in depth along the section L.

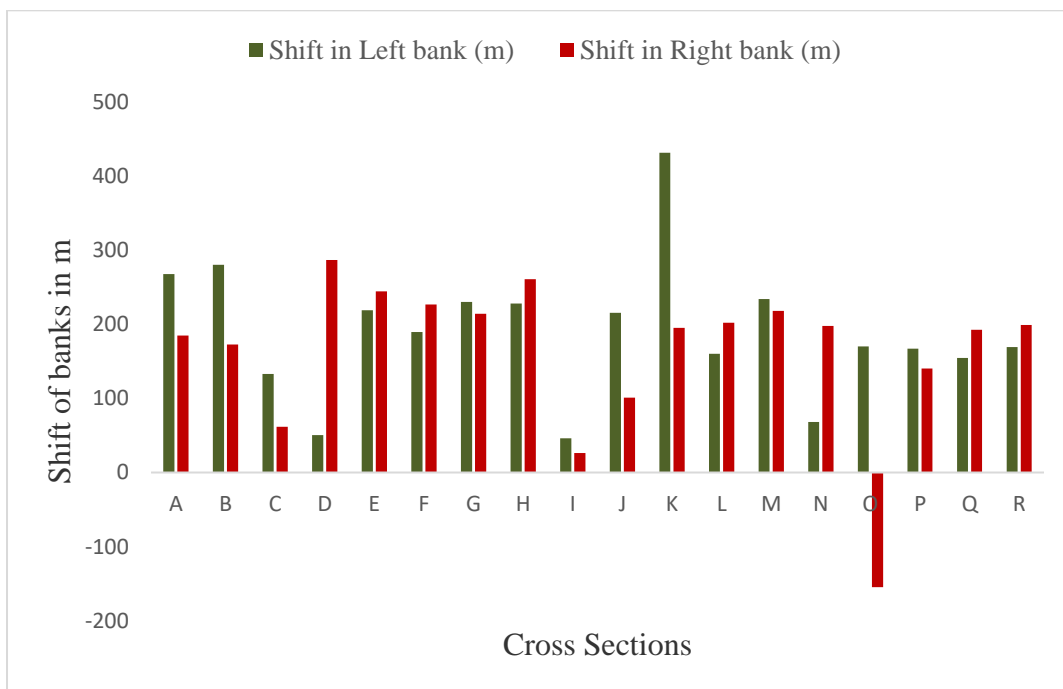
**Fig. 4. 19 Shifting along both banks of the Kuttippuram to Pattambi reach of Bharathapuzha river from 1990 to 2017**

As the river Bharathapuzha is flowing from North to West from the Anamalai hills in the Western Ghats to the Arabian sea, the shifting of the bank line indicates the shift of river. It showed a trend of shift towards the northern side. Except the section O all other sections showed a northern shift whereas O section exhibited a southward shift. Shift in both banks in opposite direction was only detected in the section O. Left bank shifted towards north about 170.407 m and right bank towards south about 155 m. Large variation in shift between banks had occurred along the section K in the same direction. Right bank shifted about 431.92 m and left bank by 195.42 m. The bank line shifting was identified significantly towards north along the Kuttippuram to Pattambi stretch of the Bharathapuzha river. Similar studies were reported by Reza and Islam, (2016).

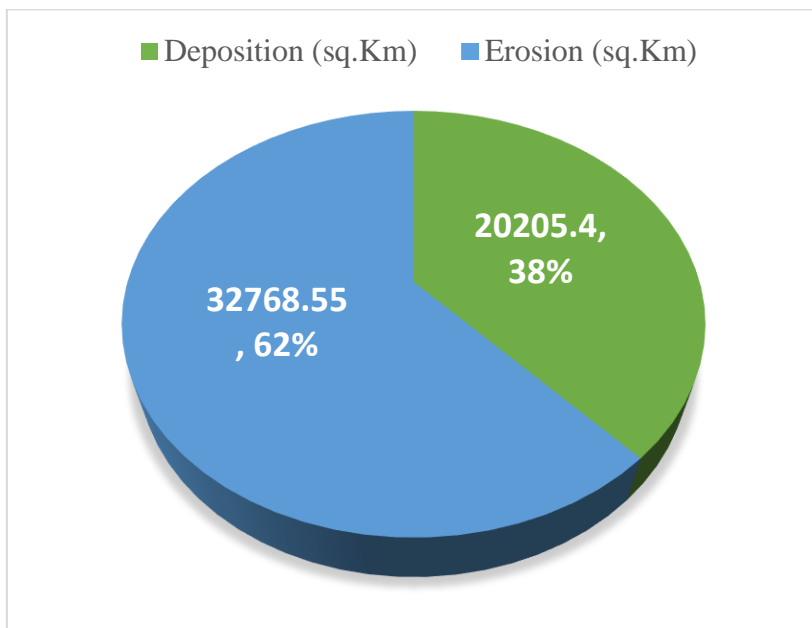
**Fig. 4.21 Total erosion/ deposition along the banks of Kuttippuram to Pattambi reach of Bharathapuzha river from 1990 to 2017**
